Release Notes

3Com® Router 5000 and 6000 Family

Software Version 2.41

Part Number: 10015046 rev. AC

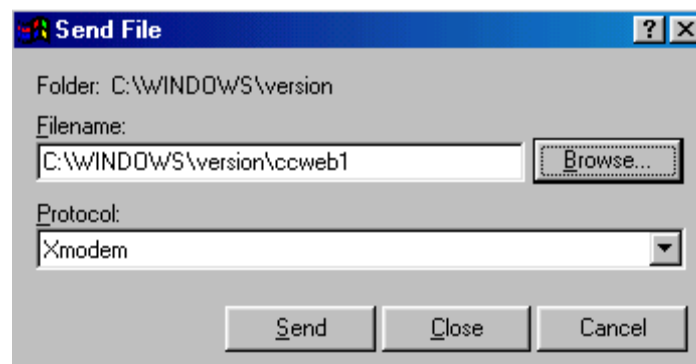
- 4 Select [Transfer/Send File] in the terminal window. The following dialog box pops up:

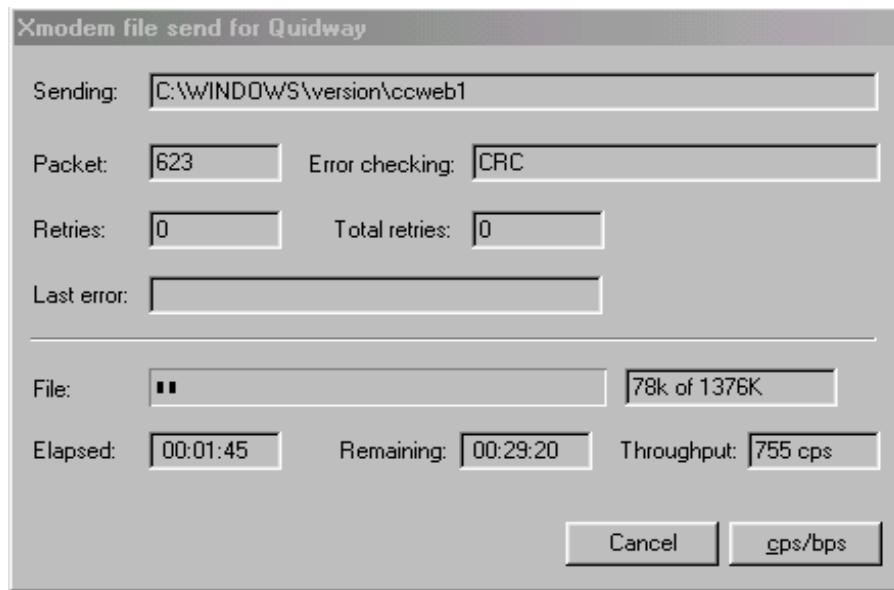
- 5 Click <Browse>. Select the file to be downloaded and set protocol to Xmodem. Click <Send>. The following interface pops up:

The image shows a dialog box titled "Xmodem file send for Quidway". It contains several input fields and buttons. The "Sending:" field is set to "C:\WINDOWS\version\ccweb1". The "Packet:" field is set to "623" and the "Error checking:" field is set to "CRC". The "Retries:" field is set to "0" and the "Total retries:" field is set to "0". The "Last error:" field is empty. Below these fields, there is a "File:" field with a double bar icon and a progress indicator showing "78k of 1376K". At the bottom, there are three fields: "Elapsed:" set to "00:01:45", "Remaining:" set to "00:29:20", and "Throughput:" set to "755 cps". There are two buttons at the bottom right: "Cancel" and "cps/bps".
